# ILUMEN PID SOLUTION

Independent party testing

## Confirmation of regeneration

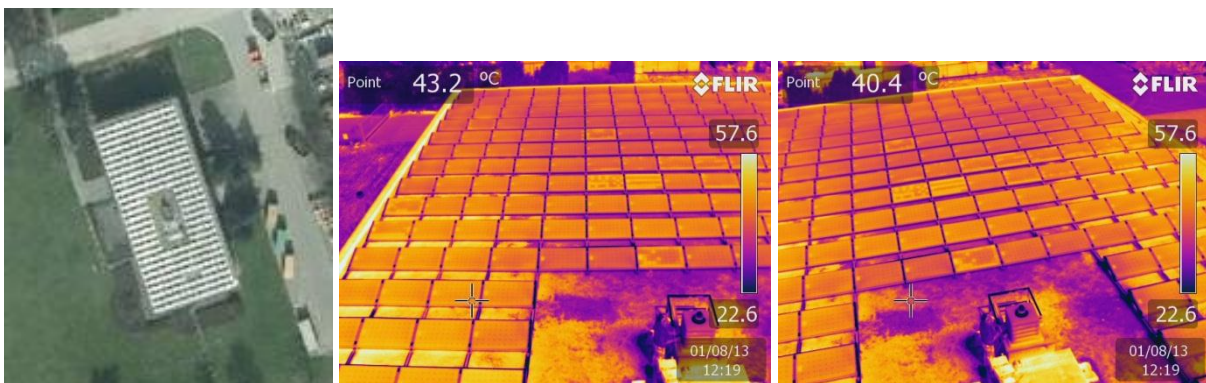
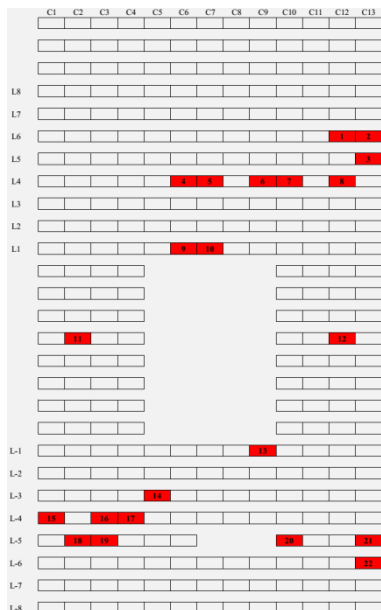
To start ELIOSYS selected a demo project with sting configuration A: 3x19 and B: 1x20 from which the 4 worst modules would be tested before, during and after the regeneration process with the Ilumen PID Solution. Determining the PID infection in the PV installation was done on site (result shown by some pictures below). The modules have a 245Wp nominal datasheet value but to set the reference first the real power of the good modules was determined.

Open circuit voltage turned out to be the easiest and most effective first indicator for finding PID. EL measurement is used to confirm the first prediction. Infrared imaging would only be possible on high radiation days (<30 days per year in Belgium) and only during the noon time (10-16h).

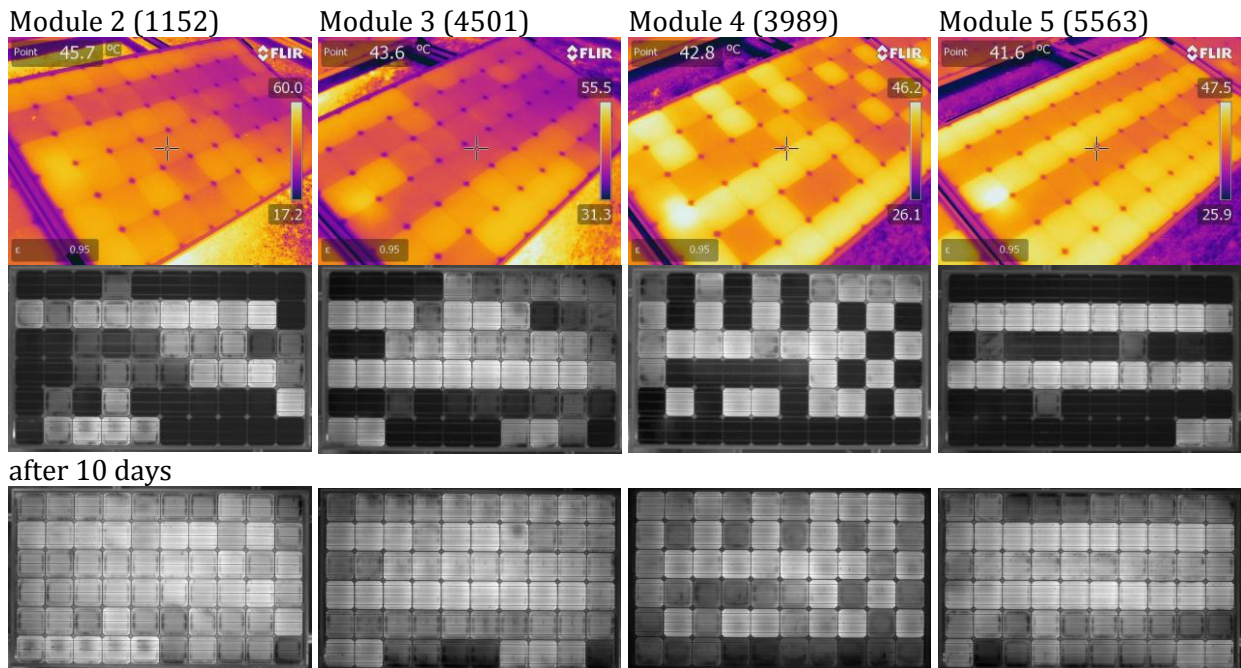
Infra-red (IR) and electroluminescence (EL) photos of the selected infected panels:

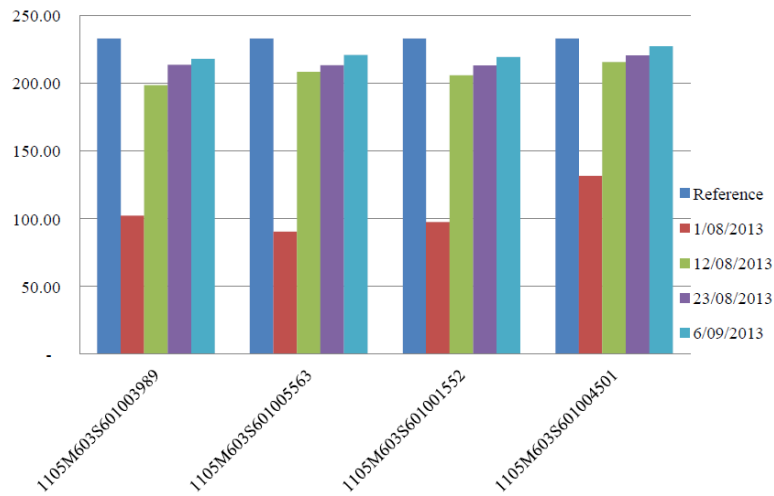
**Power Evolution**

Latest results, after 35 days of regeneration, showed effective curing of the modules back to 95% of reference power on average with even one panel to 98%.
